NASA-DoD Lead-Free Electronics Project

Joint Test Report - Final

December 2011

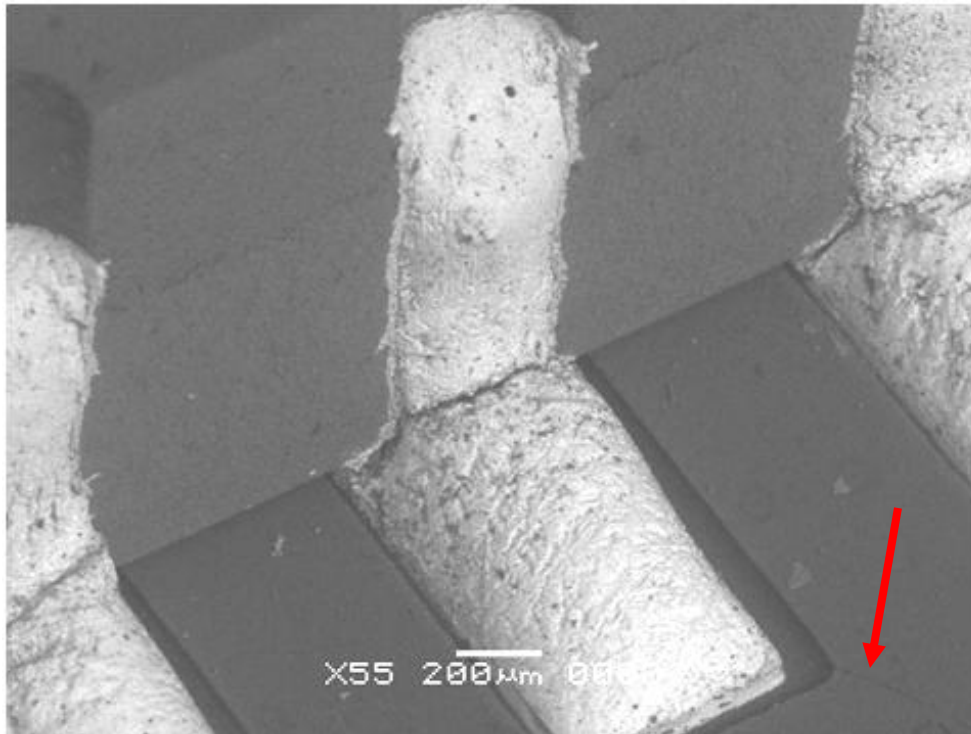
Figure 232 – U13 CLCC, SEM Image, Lead 8, Solder Crack and Solder Mask Crack (X55)

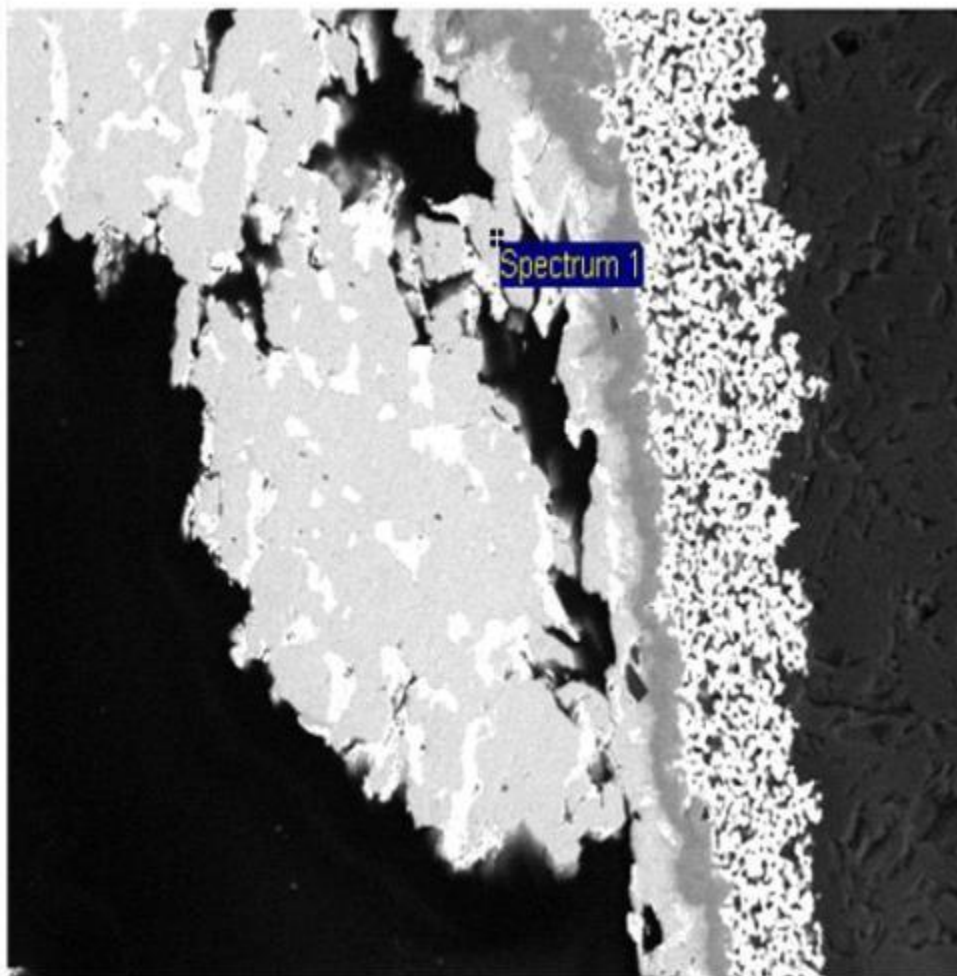
Figure 233 – U13 CLCC, Cracks Developed Through Sn Phase, Lead 20

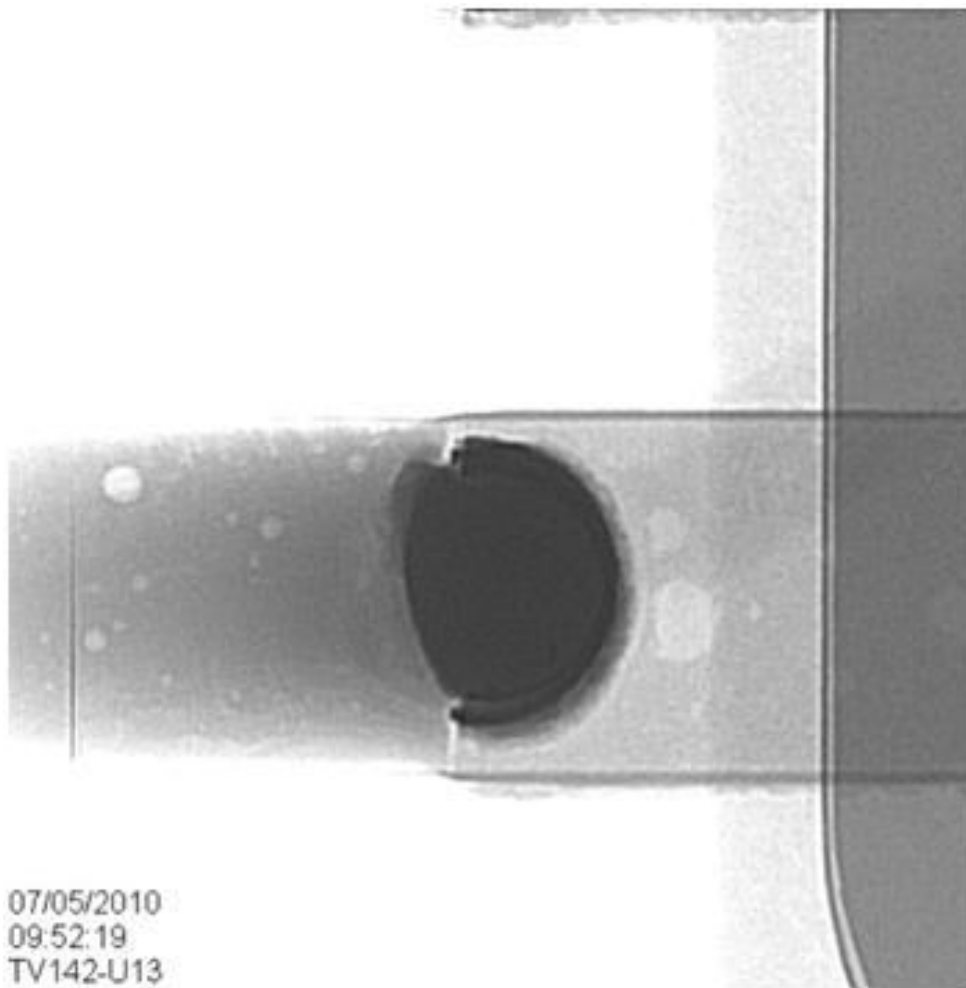
Figure 234 - U13 CCLC, X-ray Image, Voiding, Lead 20

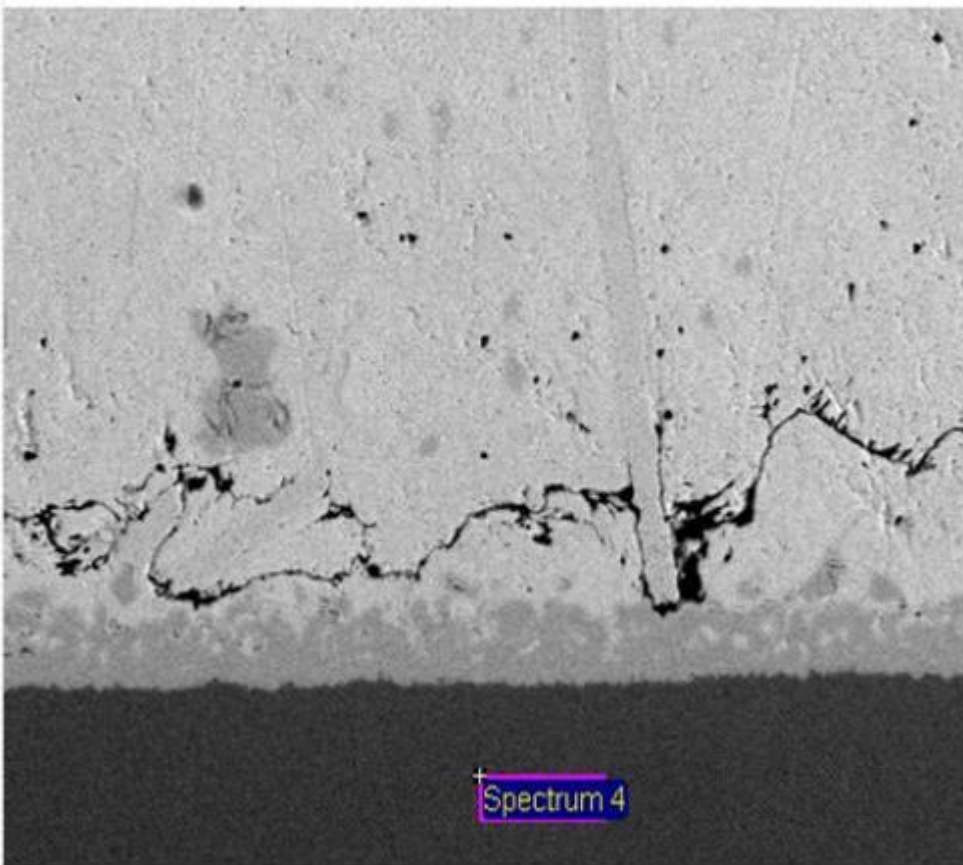
Figure 235 – U56 BGA, Solder Ball A15, Cracks Developed at SnCu Phase

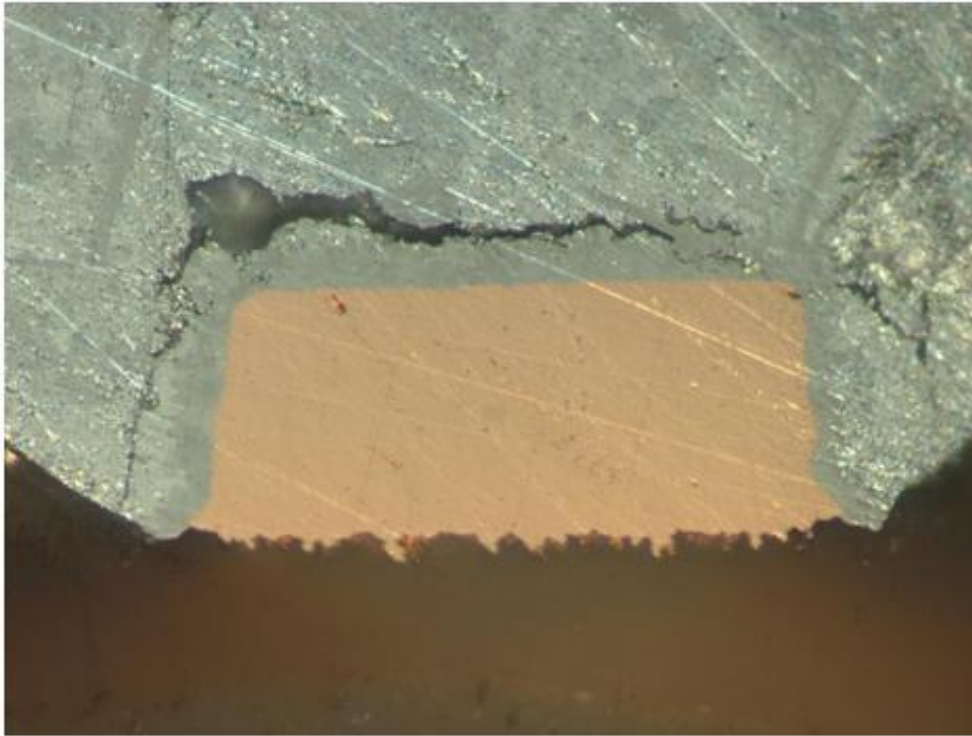
Figure 236 – U56 BGA, Cross Sectional View of Solder Ball A9, Void in Solder Joint (X682)

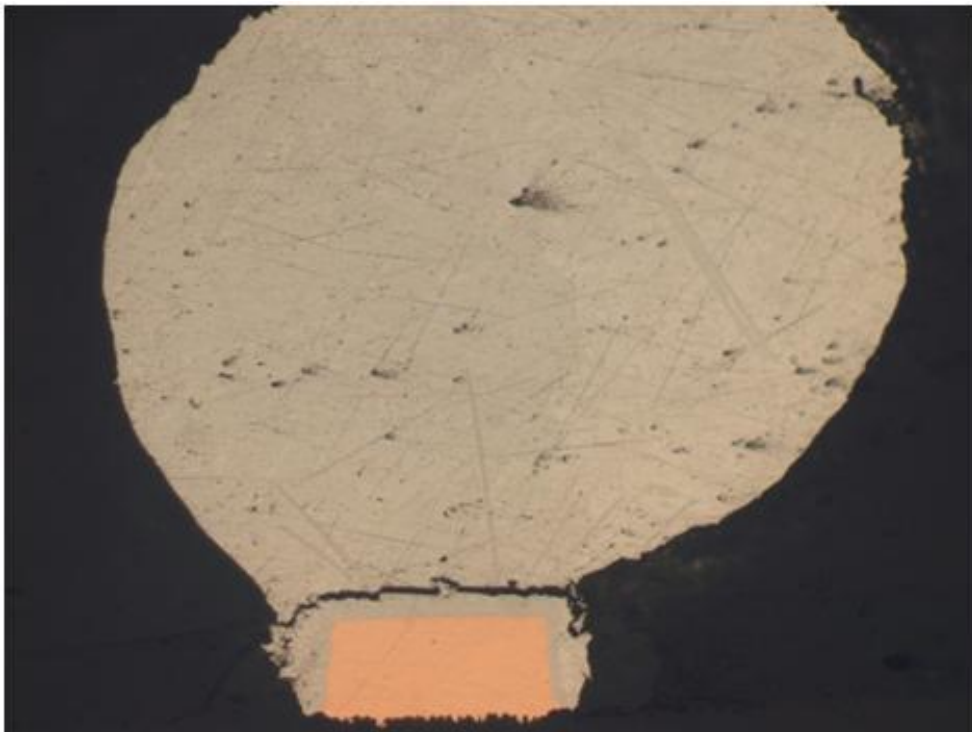
Figure 237 – U56 BGA, Cross Sectional View of Solder Ball A7, Crack on the Solder Joint at PCB Trace Interface

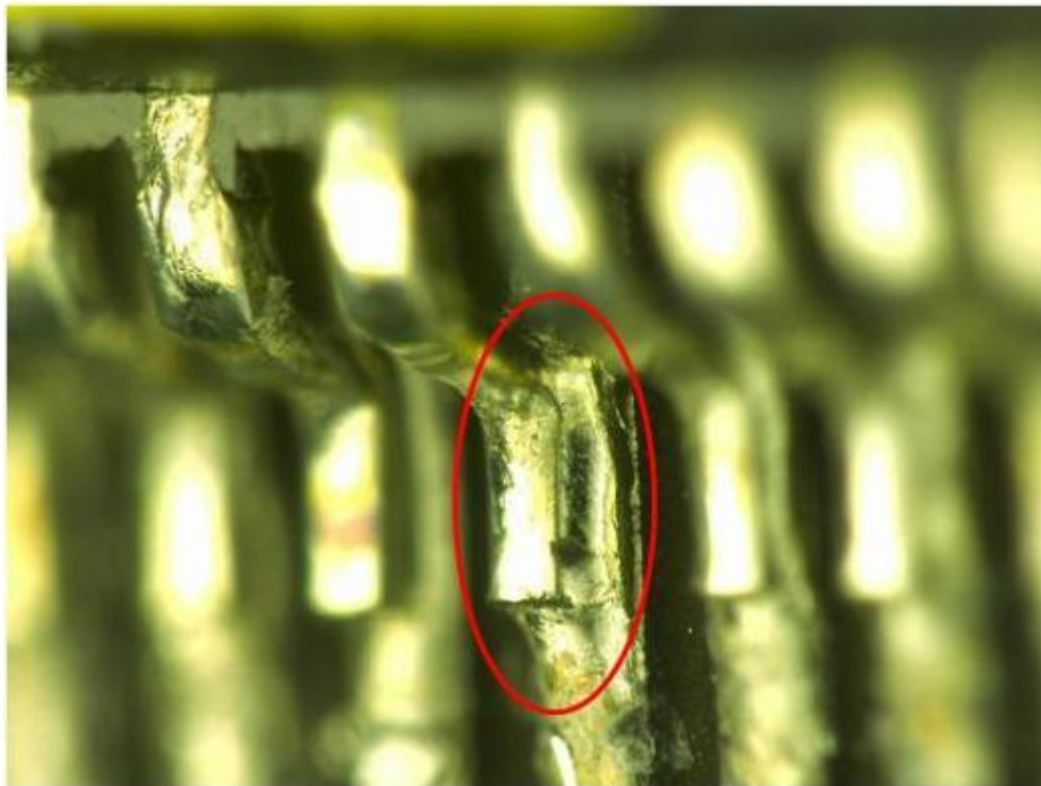
Figure 238 - Test Vehicle 183, Component U41 (TQFP-144); Unsoldered Lead from the Original Manufacturing Process

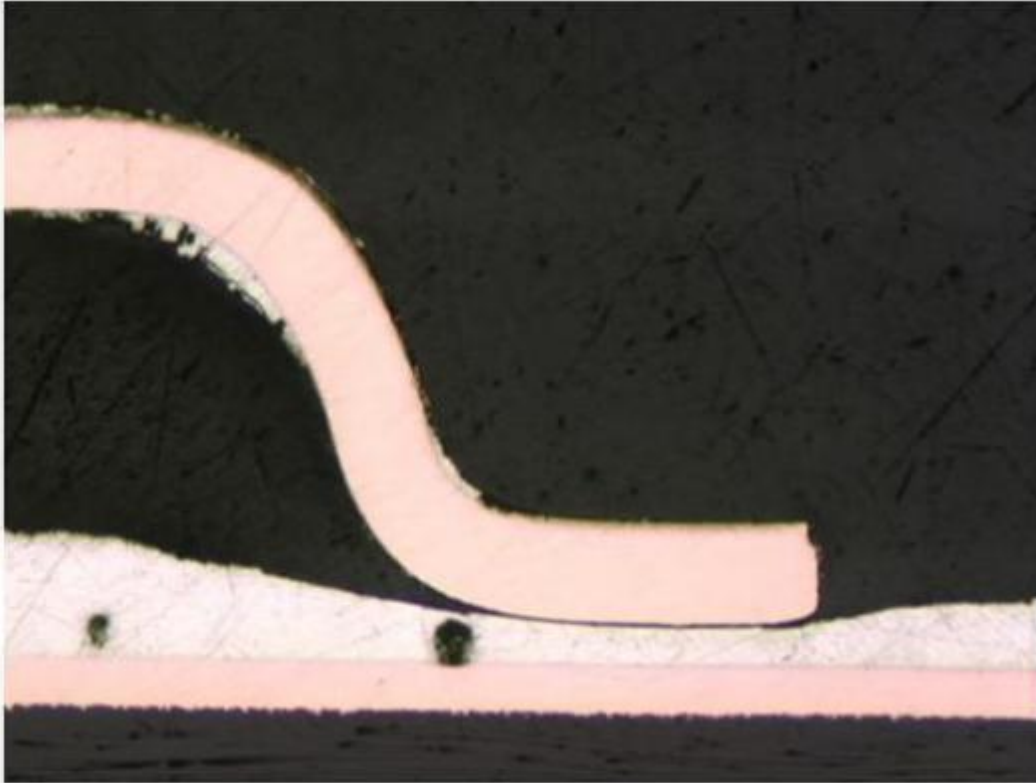
Figure 239 - Test Vehicle 183, Component U41 (TQFP-144); Unsoldered Lead from the Original Manufacturing Process

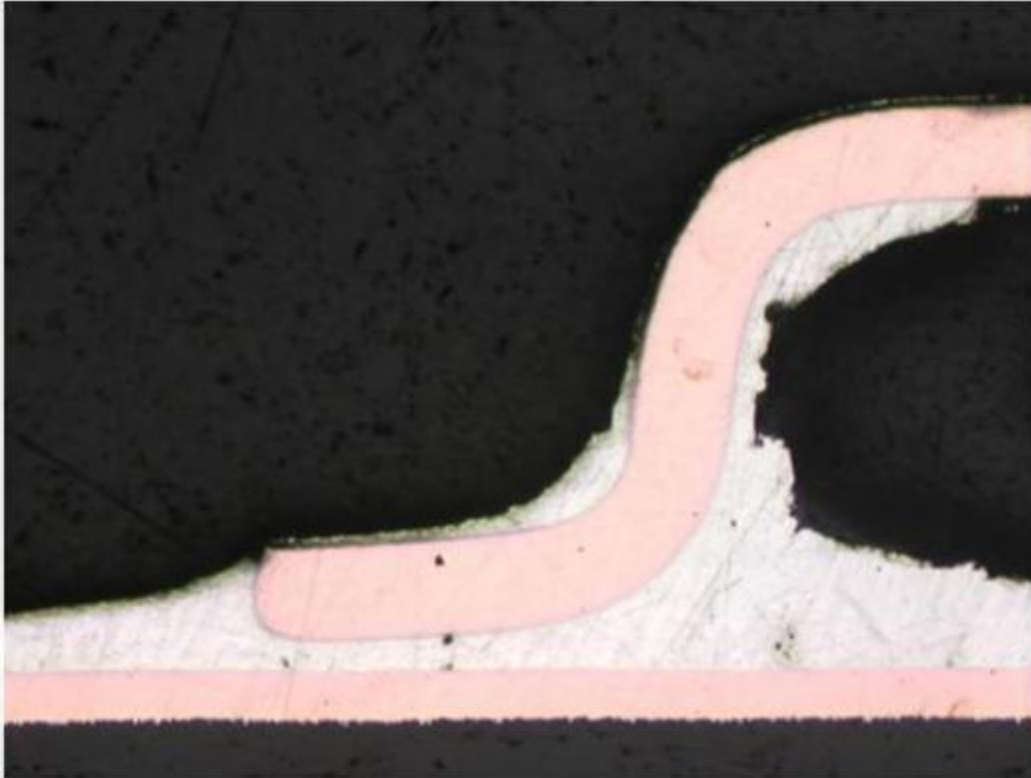
Figure 240 - Test Vehicle 183, Component U41 (TQFP-144); Solder Behind the Lead at the Heel is Irregular

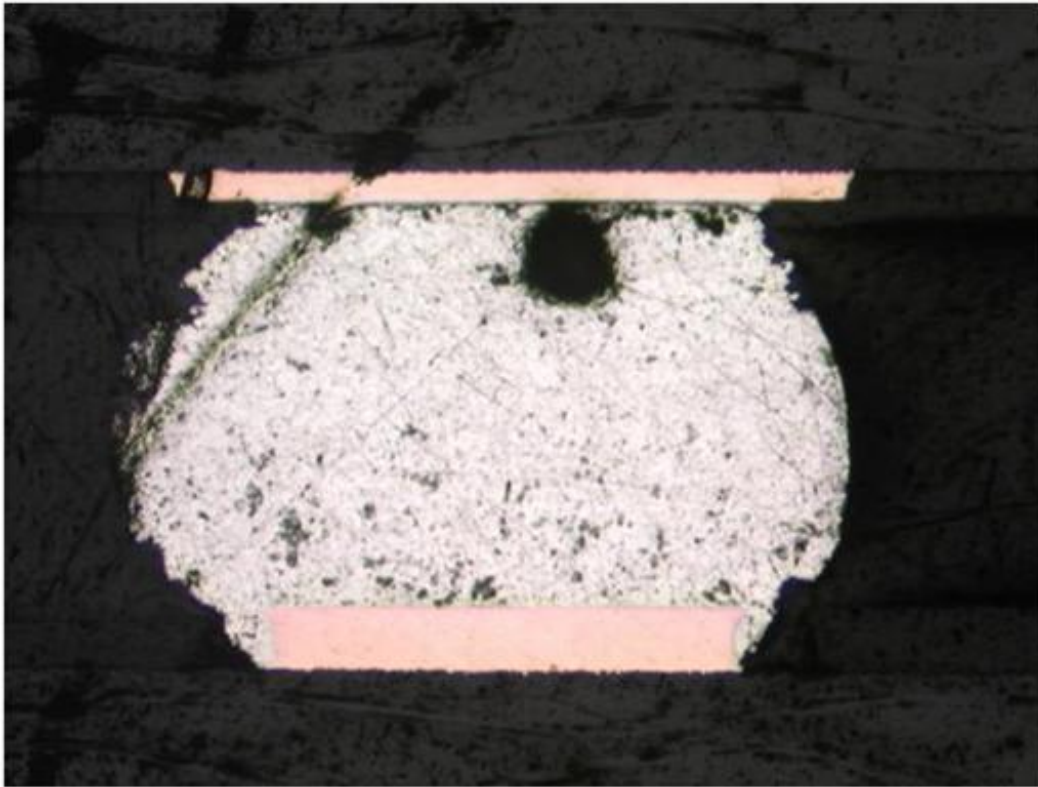
Figure 241 - Test vehicle 117, Component U4 (BGA-225); Crack at the Component Pad

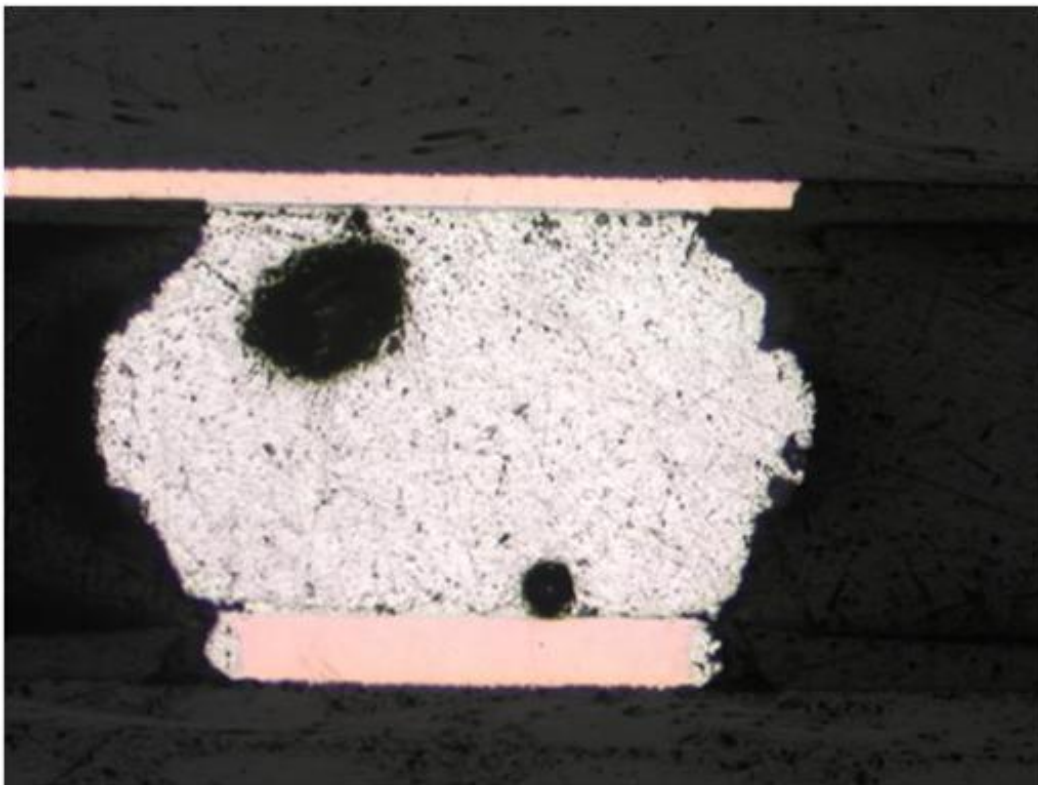
Figure 242 - Test vehicle 117, Component U4 (BGA-225); Crack at the PWB Pad

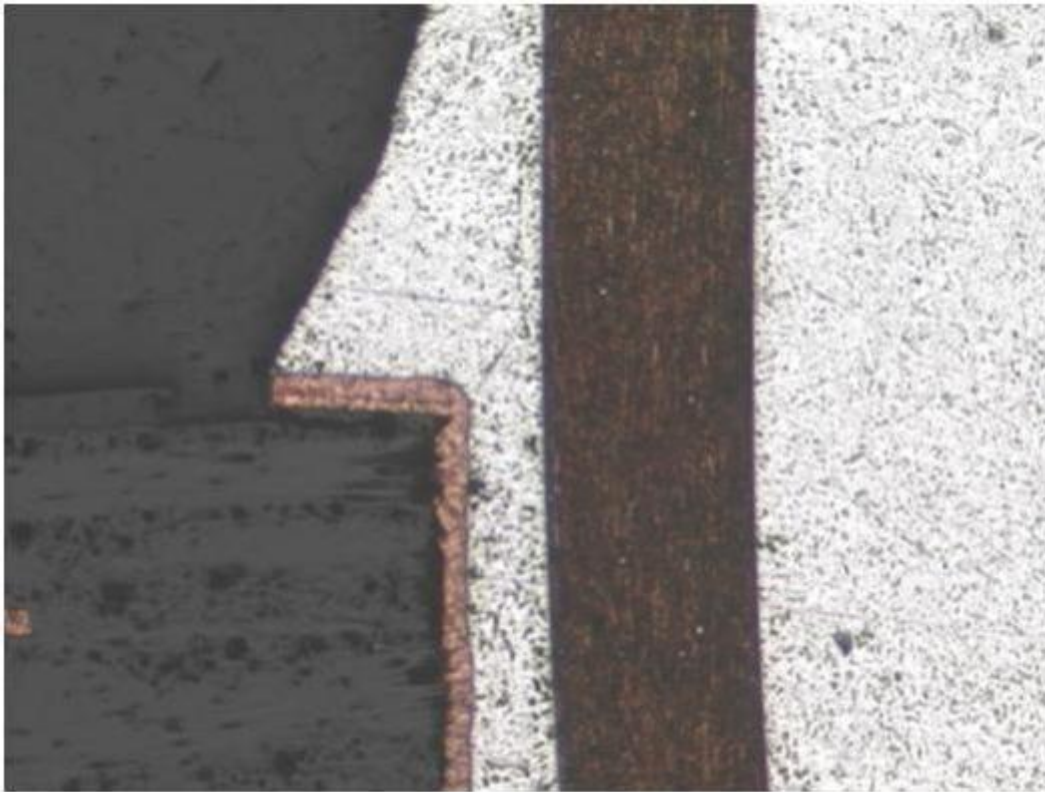
Figure 243 - Test Vehicle 140, Component U11 (PDIP-20); Lifted Pad

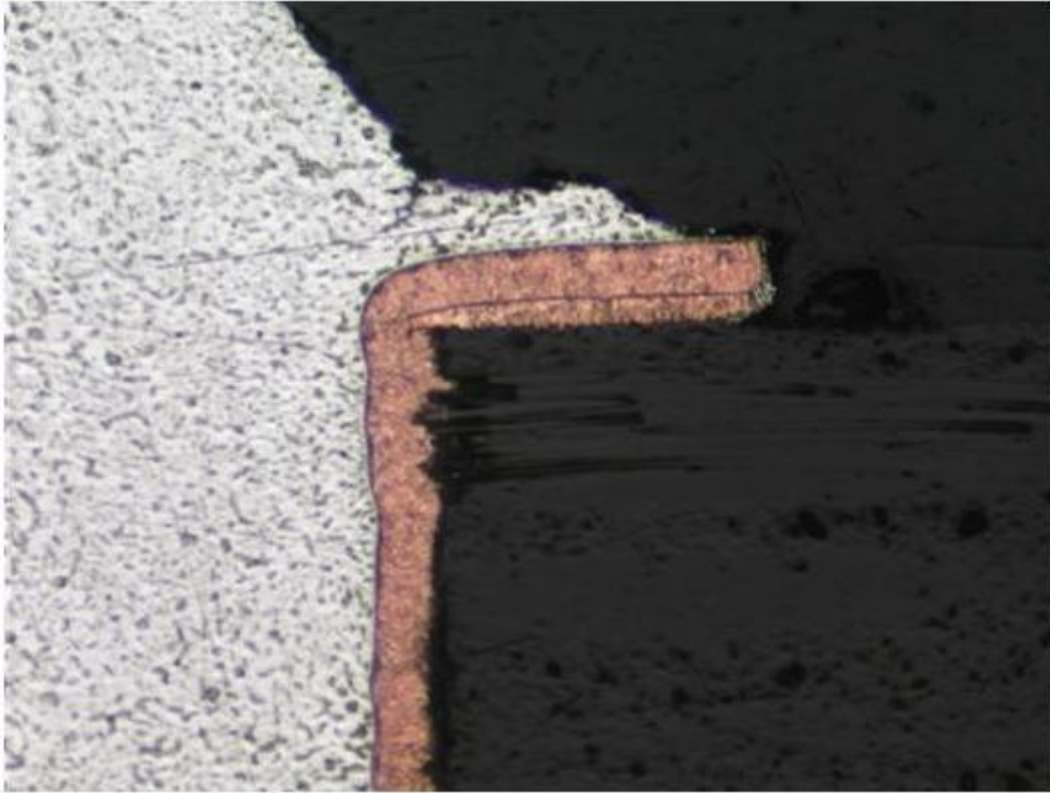
Figure 244 - Test Vehicle 140, Component U11 (PDIP-20); Partial Crack
